ARLINGTON FINANCE COMMITTEE
MINUTES OF MEETING
03/8/2023 7:30 PM
Via Remote Participation - Zoom

ARLINGTON TOWN HALL EXTERIOR CONDITIONS ASSESSMENT & RECOMMENDATIONS

December 2022

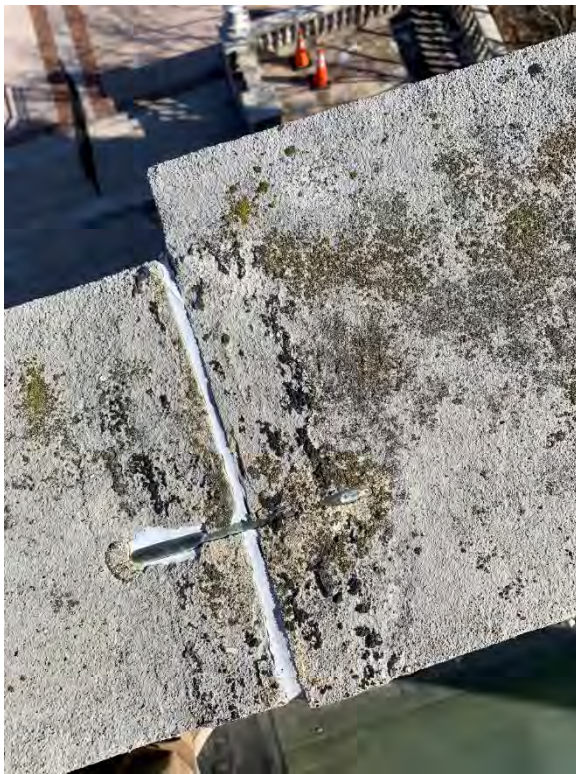
All 17,000 square feet of the Town Hall and the Annex exterior limestone walls require repointing. Failed mortar joints have allowed water to infiltrate and accelerate weathering of the stone. Joints in the stonework that face the sky need t-caps installed to prevent water entry. Limestone panels at the west elevation and at the Massachusetts Avenue entry are damaged from de-icing salts and freeze-thaw cycles. Stone balustrade units are cracked by rusting steel pins. Stone is discolored by dormant and active biological films. Repairs to cornice stones using soft steel are rusting and further damaging the stones. Soft steel anchors to stone at the west wing of the Town Hall have rusted and caused spalling of stone panels. Wall condition was evaluated by Building and Monument Conservation and their full report is included in this document.

Figure 49: A bronze staple joining two balustrade pieces together. Note the caulking in the skyward facing joints. A t-cap needs to be applied to these joints.

Fully stage the exterior of the Town Hall and Annex in coordination with roofing work. Repoint the stone walls of the Town Hall and Annex with a soft repointing mortar to prevent damage to the limestone. Install t-caps at skyward-facing joints at parapets and balustrades. Replace limestone blocks damaged by salts and frost at the Massachusetts Avenue entry and along the west elevation. Consider using a light-colored, buff granite similar to the paving granite at the main entrance to visually blend with the limestone and be less vulnerable to frost damage and de-icing salts or use cast stone based on the cupola reconstruction match to limestone. Replace rusted pins at stone balustrades with bronze or stainless steel pins when the balustrade is removed to install new flashing at the perimeter of the Town Hall roof and at the portico over the main entry. Gently clean stone during repointing which will reduce the prominence of biological films for the near term, but note that growths cannot be fully eradicated and will slowly return. Remove rusting embedded metal anchors and repair staples and replace failed stone or repair with bronze or stainless steel staples and pins as required. Replace stone panels where anchors have caused spalling. If possible, reduce the application of de-icing salts around entries.

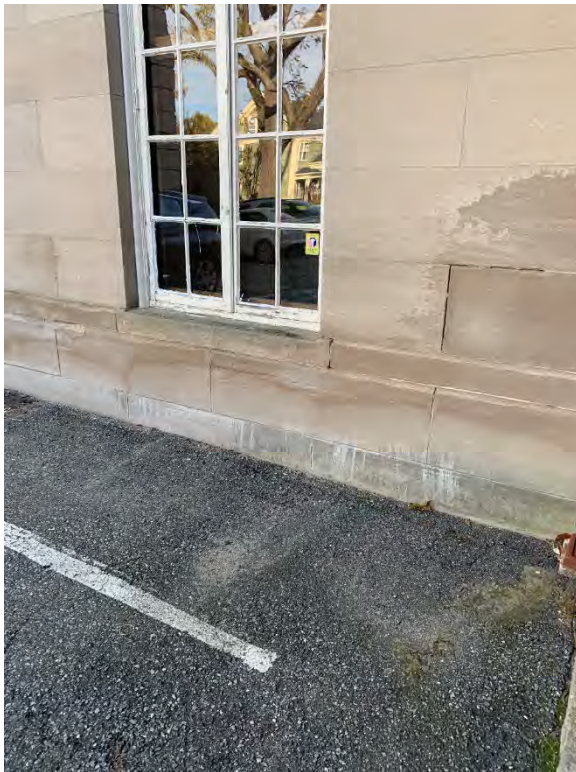
Figure 51: Limestone along the west wall discolored by water absorption and application of de-icing salts.

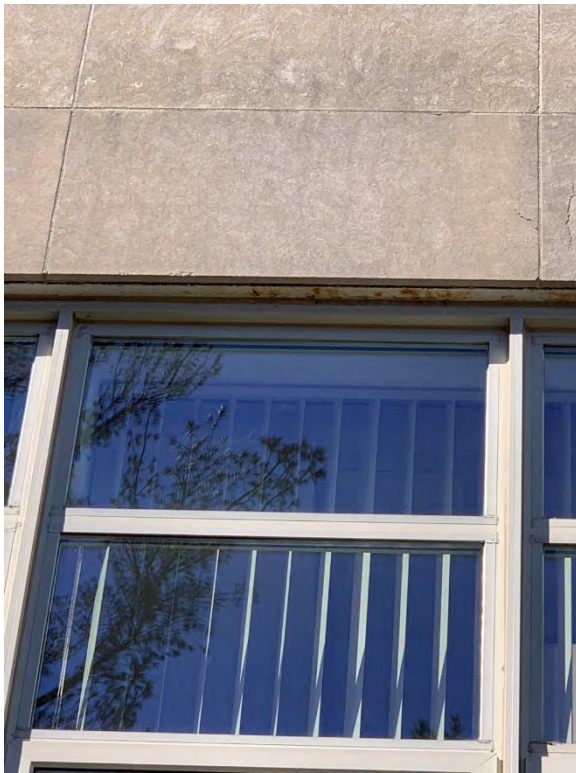
Figure 52: Rust on lintels at the Annex. Treat the rust before it damages the stone work.

Address the rusting lintels when repointing is conducted by removing rust, applying a zinc-rich primer and epoxy coating the steel.

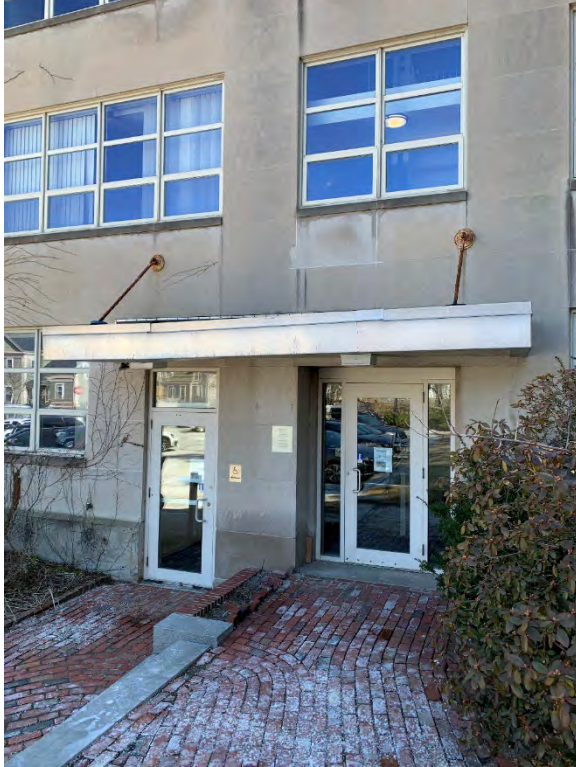
The aluminum trimmed awning at the Annex west entry is supported by two tension rods anchored to the west wall of the Annex. There is deflection at the roof and it no longer drains properly. The exterior plasterboard ceiling and lighting need replacement. The trim is dented at the northwest corner and the tension rod anchor points are rusting.

Figure 53: Annex awning. Note the rusting at the support rods, deflection of the roof toward the northwest corner and the dropping plaster ceiling.

Remove roof and plasterboard. Install tapered insulation, a fully adhered TPO roof directed to scuppers. Repair the metal rim and framing. Install a new exterior plaster board ceiling and new lighting. Remove rust from the anchor rods and paint with a zinc-rich primer and epoxy coat for finish.

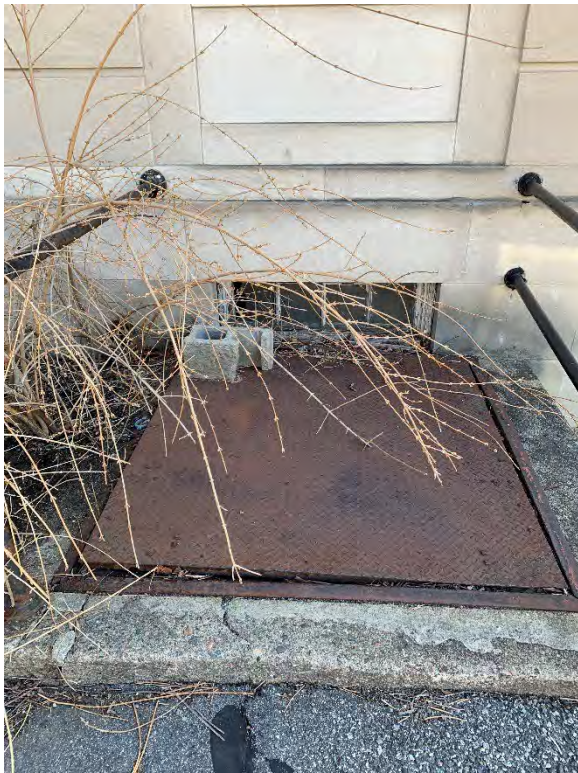
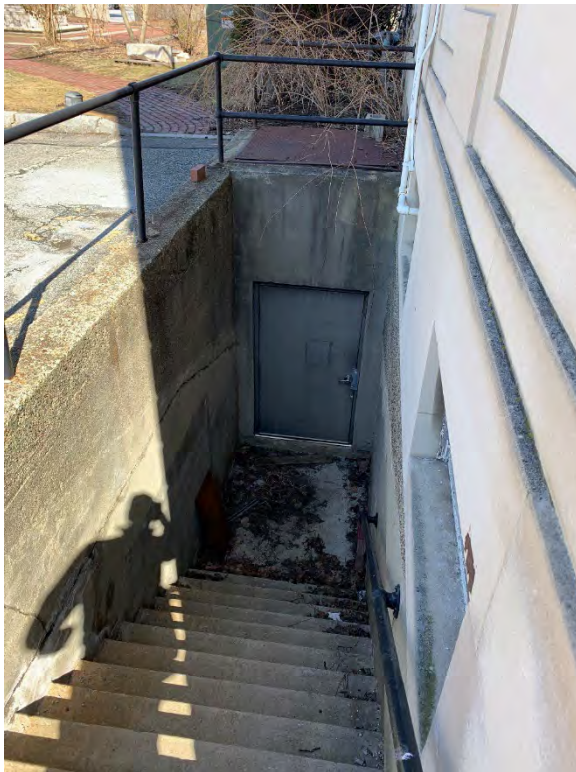
An areaway is located at the southwest corner of the Town Hall west wing. The perimeter pipe rail and metal grate cover are rusting.

Figure 54: Areaway metal cap. The rusting pieces should be treated and painted.

Remove rust from the steel and paint with a zinc-rich primer and epoxy coat for finish.

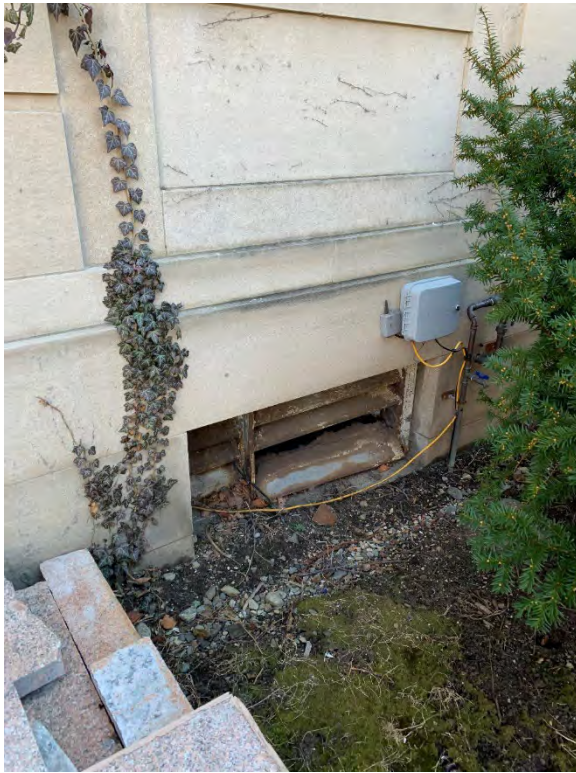
Various grilles and vents have enclosed and filled many of the basement windows of the Town Hall. The decorative grilles are rusting. The vents, combinations of louvers and sometimes PVC piping are not attractive but appear to be in fair condition. Some may no longer be being used.

Figure 56: Deteriorated louvers to be replaced if in use.

Remove rust from the steel grilles and paint with a zinc-rich primer and epoxy coat for the finish. Evaluate all vents for function. Remove those no longer required and reinstall windows. Replace active, but damaged louvers.

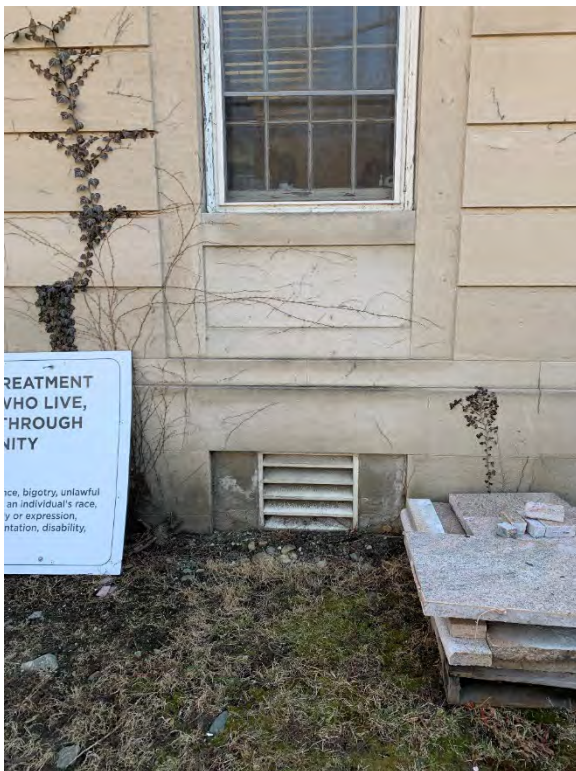
Figure 57: Other louvers. Determine if functioning.

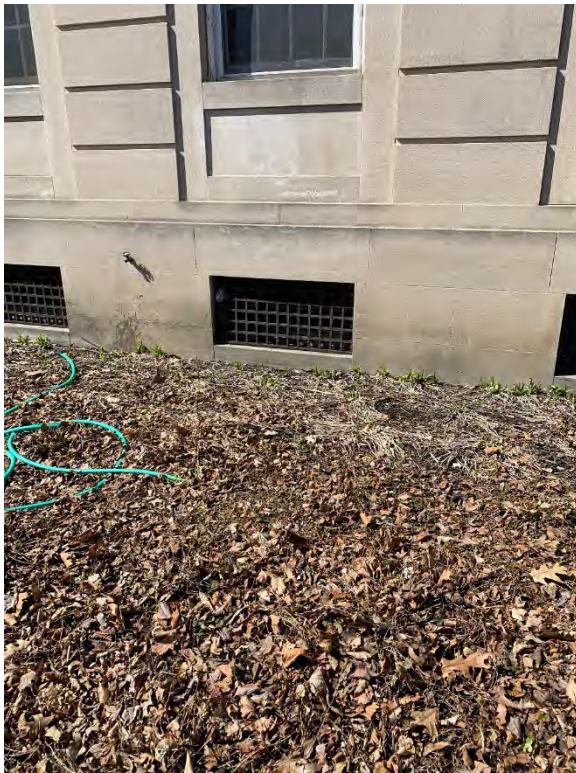
Figure 58: East side security grates are rusting and need painting.

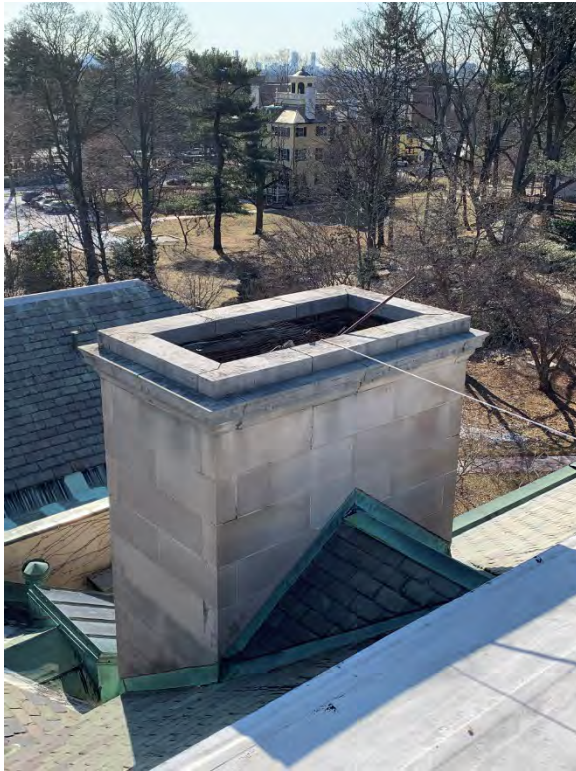
Two, limestone clad chimneys at the Town Hall appear to vent mechanical spaces. Mortar at the cladding is eroded and the mortar at the brick back-up is severely eroded. A circular, rusted vent pipe extends out the top of the west chimney. A broken wood frame is perched on the east chimney.

Figure 59: East chimney at the Town Hall. The wood and wire debris will be removed when repointing is done.

Pointing would be carried out along with the wall repointing. Remove the rusted vent pipe and wooden frame. If the chimney's are not in active use, cap the opening with a stone slab. If active, when repointing, install t-caps at the skyward facing stone joints and establish a mortar wash to protect the tops of the brick back-up.

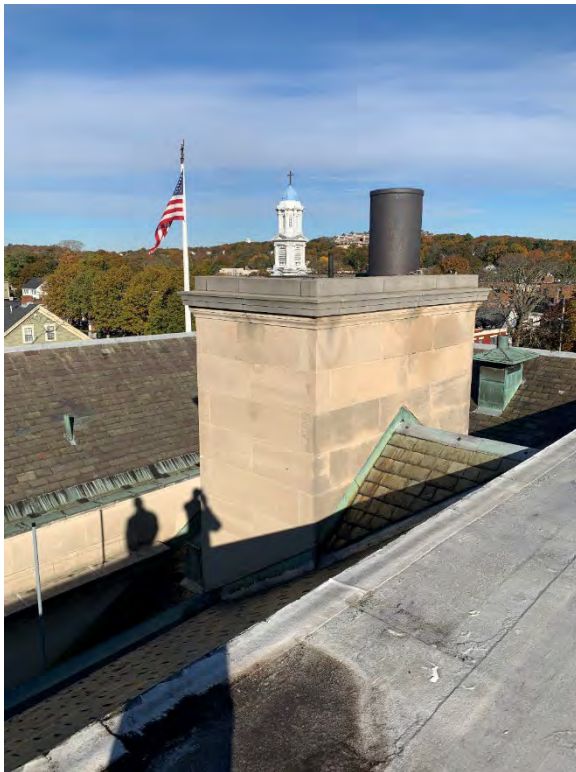
Figure 60: The west chimney includes a rusted sheet metal pipe stack.

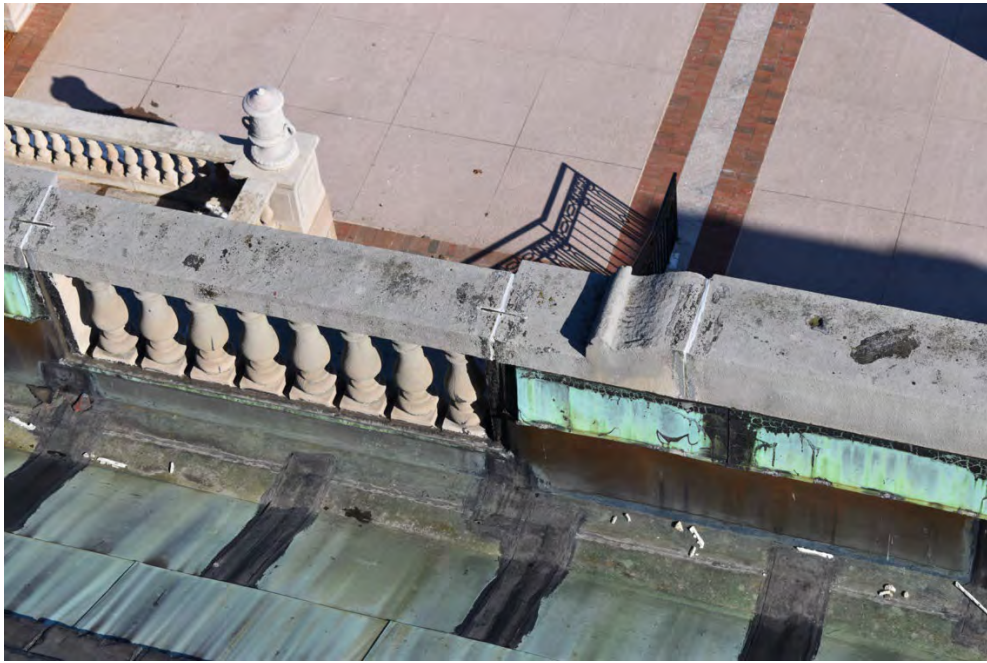
Bronze cramp anchors set in small kerfs cut into the stone are visible at the top of the balustrade coping units. Since most of the balusters do not exhibit cracking, it is likely that bronze pins were used to secure these units to each other. The cracks in the balusters at the front of the building may be an indication that steel pins were substituted for bronze in some locations. When the balustrade on the front and sides is removed to replace the deteriorated roof flashing, all of the individual stone units should be checked for steel pins. Cracked or broken balusters will have to be replaced with new limestone units and all steel pins will have to be removed and replaced with stainless steel or another type of non-corrosive pin.

Photo 9: Bronze anchors were used to secure the balustrade coping stone to each other.

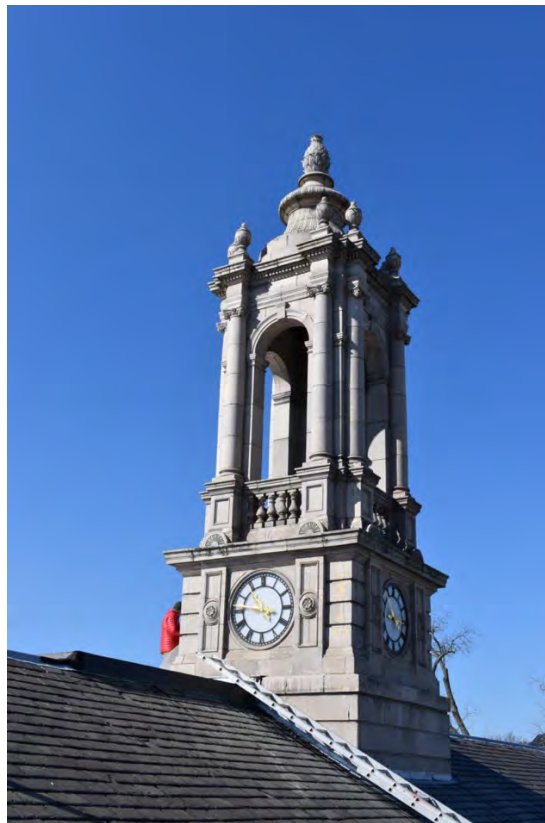
The clocktower is exhibiting several types of advanced deterioration. Many of the terra cotta units are cracked – some in several locations. **(Reference photos 19 & 20)** The exposed portions of the concrete walls are cracking and spalling from the corrosion of the steel reinforcement located in the concrete. **(Reference photo 17)** There is widespread glaze failure and spalling of the exposed clay. **(Reference photo 20)** The steel reinforcing at the roof of the belfry is corroding. **(Reference photo 18)** One of the two urns on the northwest corner has a large crack.

Photo 16: The terra cotta clocktower appear to be in relatively good condition when viewed from a distance but when it is viewed up close the problems are very visible.

Unfortunately, the clocktower has deteriorated beyond the point of repair. Due to the manner in which terra cotta structures were built with steel supports and anchors buried inside the structure, it is not possible to reach and repair or replace the steel without cutting the terra cotta to expose the steel. At this point in time, the only option is to replace the clocktower either with new terra cotta or another material that closely resembles terra cotta. The least expensive solution would be to replace the clocktower with a new structure clad in a thin shelled material such as Glass Fiber Reinforced Plastic (fiberglass) or Glass Fiber Reinforced Concrete (GFRC). The most expensive solution would be to replace the clocktower with new terra cotta or cast stone.

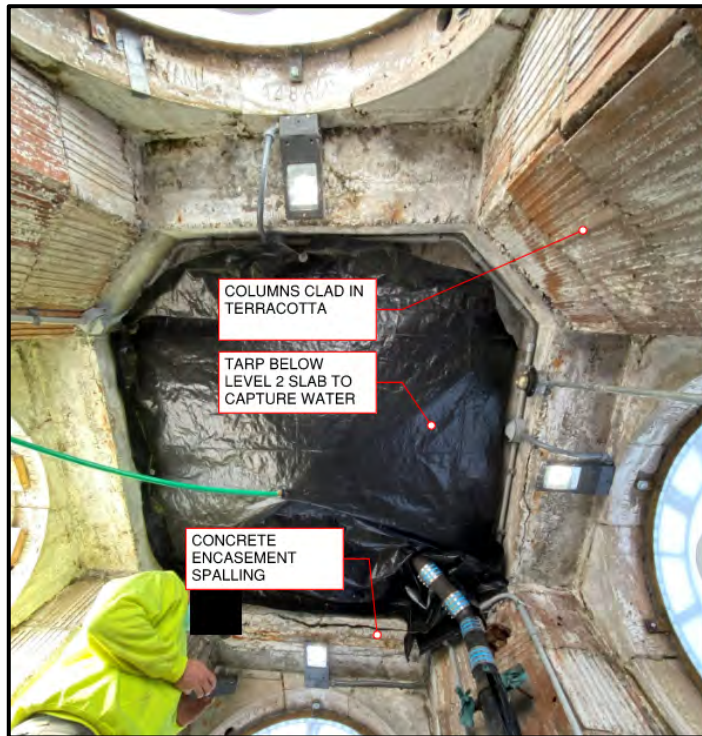
The concrete encased steel beams spanning to the columns and supporting the level 2 platform are in poor condition. Rust staining is visible on the underside of the concrete, as well as cracking and spalling of the concrete encasement. Silman removed a piece of the spalling concrete from one of the beams and observed significant corrosion of the member (see figure 6). Similar cracking and spalling of the concrete encasement is visible at the other three beams, indicating these members are likely corroding as well. We were unable to ascertain the size or shape (i.e. wide flange, channel or angle) of the steel members in this area based on the limited exposure

Figure 4 Photo taken looking up at the underside of the level 2 platform.

In the short term, Silman recommends that the level 2 beams that are corroding and causing the concrete encasement to spall, be temporarily shored down to the level 1 structure below. The intent of this shoring to help mitigate the sag over the clock faces as seen from the exterior, and likely being caused by loss of steel section in the supporting members. It is not intended to arrest further deterioration. It should be noted that these members are aggressively corroding, and as this condition continues to worsen over time, further rust jacking of the concrete encasement may cause the exterior stones to be displaced.

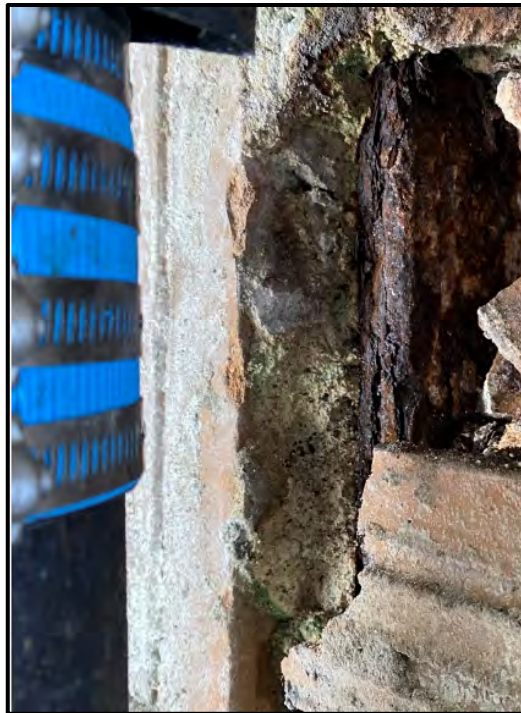
At the level 1 platform, the 4" cast in place concrete slab appears to be in good condition from both the underside and top. The double angle columns are clad with terracotta at the interior space between level 1 and level 2 (see figure 4). The majority of the columns are concealed by the terracotta but a small opening at one of the columns revealed significant corrosion of the member (see figure 5).

Figure 5 An opening in the terracotta revealed significant corrosion of the double angle column.

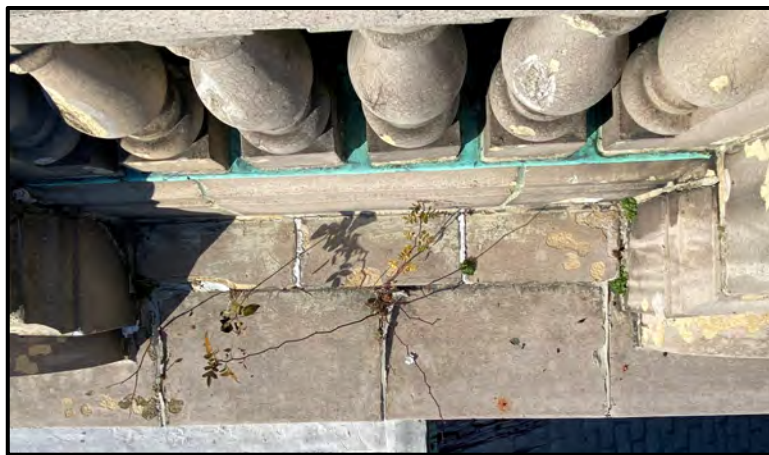
The exterior of the clock tower is clad in stone. Weathering and deterioration of the mortar joints between the stones was visible on all sides of the clock tower. Vegetative growth was also visible in some of these joints (see Figure 7).

Figure 7 Deterioration of mortar joints and vegetative growth was visible on all sides of the clock tower.
